1. Report No. NASA CR 135306		2. Government Accession No.		3. Recipient's Catalog No. N78-17216	
4. Title and Subtitle DEVELOPMENT OF Si ₃ N ₄ AND SiC OF IMPROVED TOUGHNESS				5. Report Date October 25, 1977

6. Performing Organization Code	
7. Author(s) John J. Brennan and Charles O. Hulse				8. Performing Organization Report No. R77-912252-23	
9. Performing Organization Name and Address United Technologies Research Center East Hartford, CT 06108				10. Work Unit No.

Development of Si₃N₄ and SiC of Improved Toughness

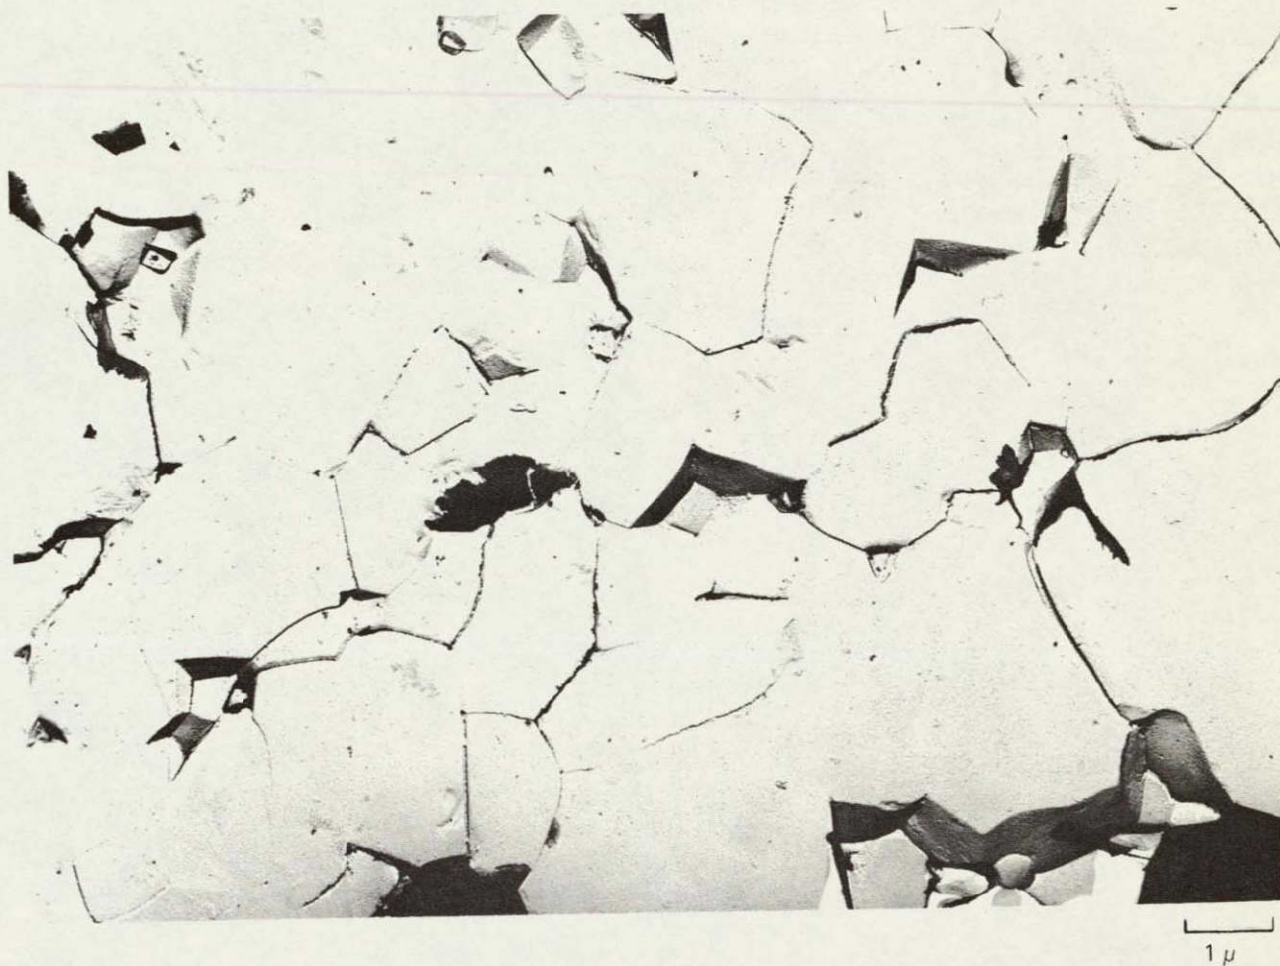
76-02-61-1

ELECTRON MICROGRAPH OF SiC SAMPLE NC-203

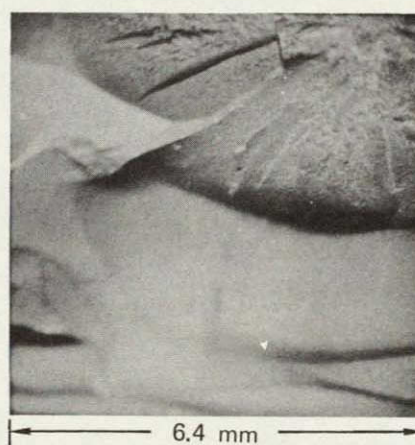
FRACTURE SURFACE OF Si_3N_4 IMPACT CONTROL (RT)

(ORIGIN AT EDGE)

The fracture origins at all temperatures for both materials were approximately evenly divided between the sample edges and the sample faces. A typical fracture origin for Si_3N_4 , tested at RT, at a face is shown in Fig. 4 and that at a sample edge in Fig. 5. Very few fracture origins were at identifiable flaws or inclusions, either external or internal. It was noticed that the samples with high impact energies fractured into four or more pieces, while the low impact energy samples fractured essentially into two pieces. Also, the weaker samples had a much smoother fracture surface than the stronger samples.

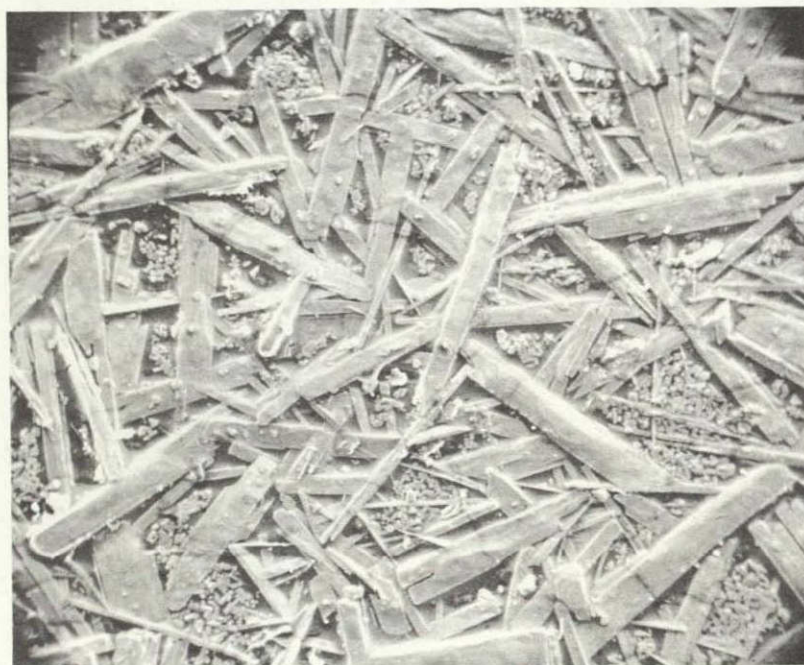
OXIDIZED SURFACE (60 HRS. AT 1350°C) OF
UTRC Si_3N_4 + 15% Y_2O_3 (100x)

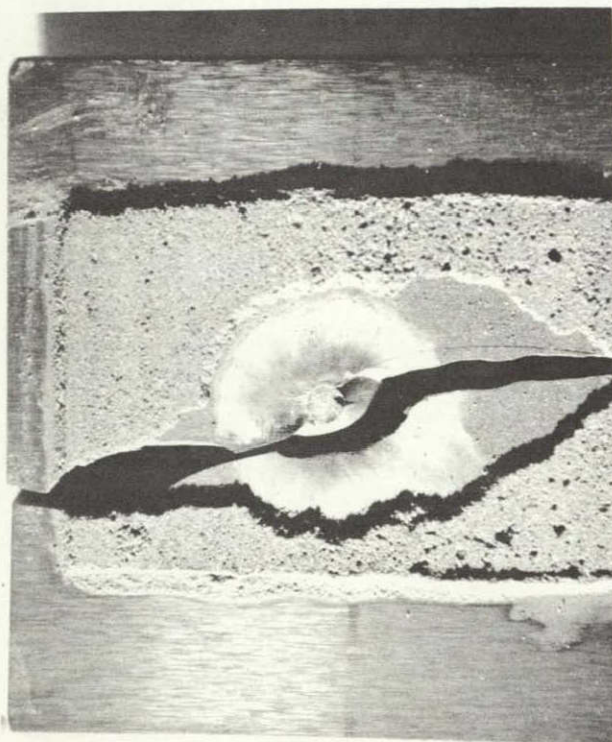
R.T. BALLISTIC IMPACT OF SILICA-ZIRCON LAYER ON Si_3N_4 AT 230 M/SEC
(9.1 JOULES)

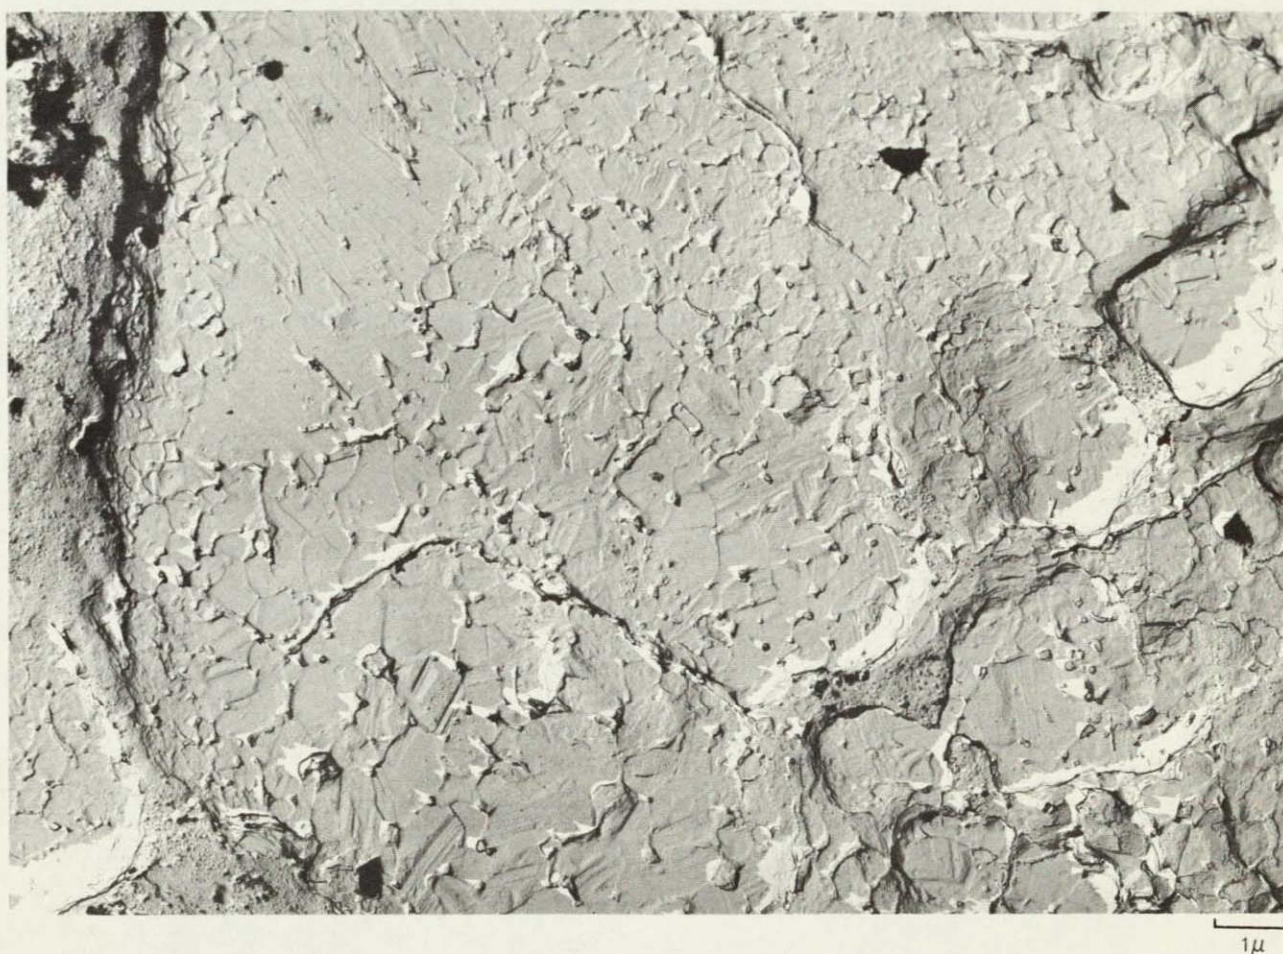
TEM OF REPLICA FROM $\alpha\text{Si}_2\text{O}_3$ FORMED FROM AMORPHOUS SiO_2 AFTER 1200°C, 1 HR HEAT TREATMENT.

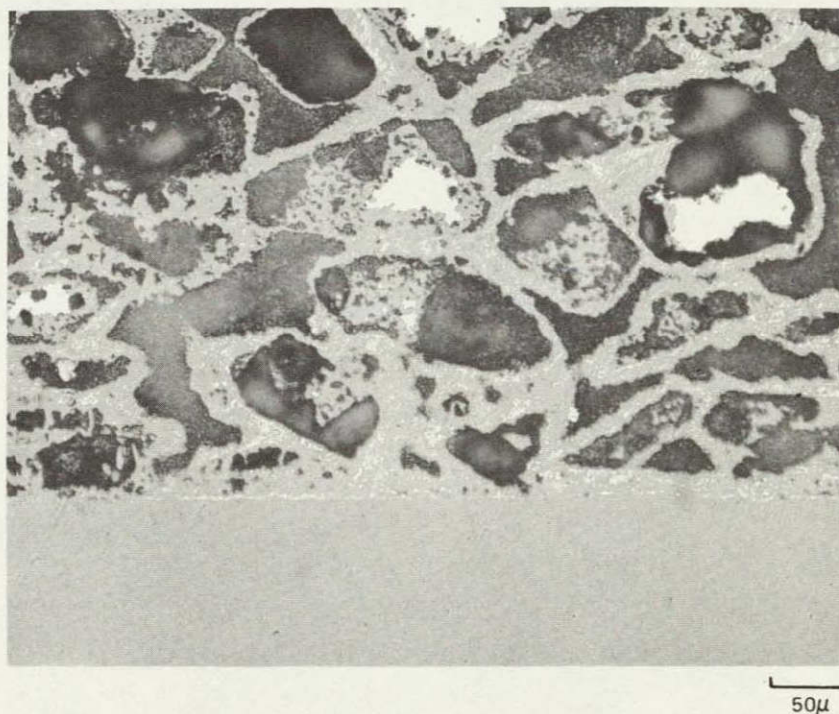
INTERFACE BETWEEN—100, + 200 Si LAYER (WATER SLURRY) AND NC-132 Si_3N_4 ,
NITRIDED AT 1375°C
(POROSITY OF R.S. Si_3N_4 LAYER $\sim 50\%$)

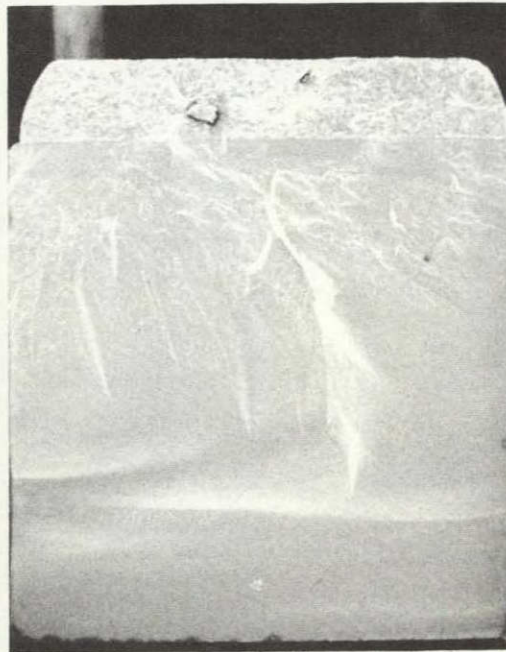
FRACTURE SURFACE OF NC132 WITH R.S. Si_3N_4 LAYER (-325 Si)
(SAMPLE 132-318) POST OXIDIZED 1300C, 1 HR

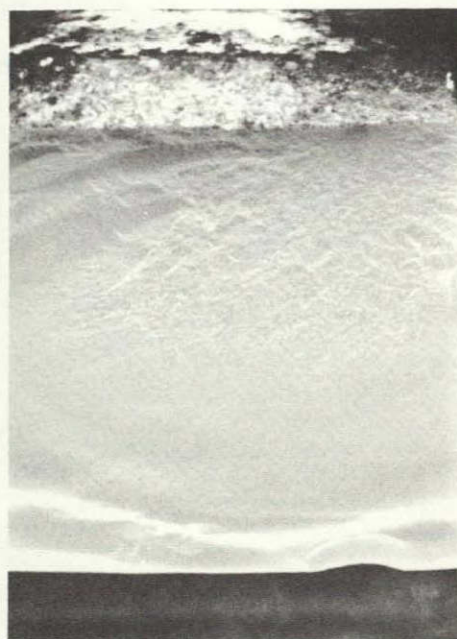
FRACTURE SURFACE OF NC-132 WITH R.S. Si_3N_4 LAYER (-200 Si)
(SAMPLE 132-325) (IMPACTED ON SIDE OPPOSITE R.S. Si_3N_4 LAYER)
